| STS-114 Flight Readiness Review | Presenter Alex Adams | |

Space Shuttle Program Safety & Mission Assurance Office

STS-114 CoFR Endorsement

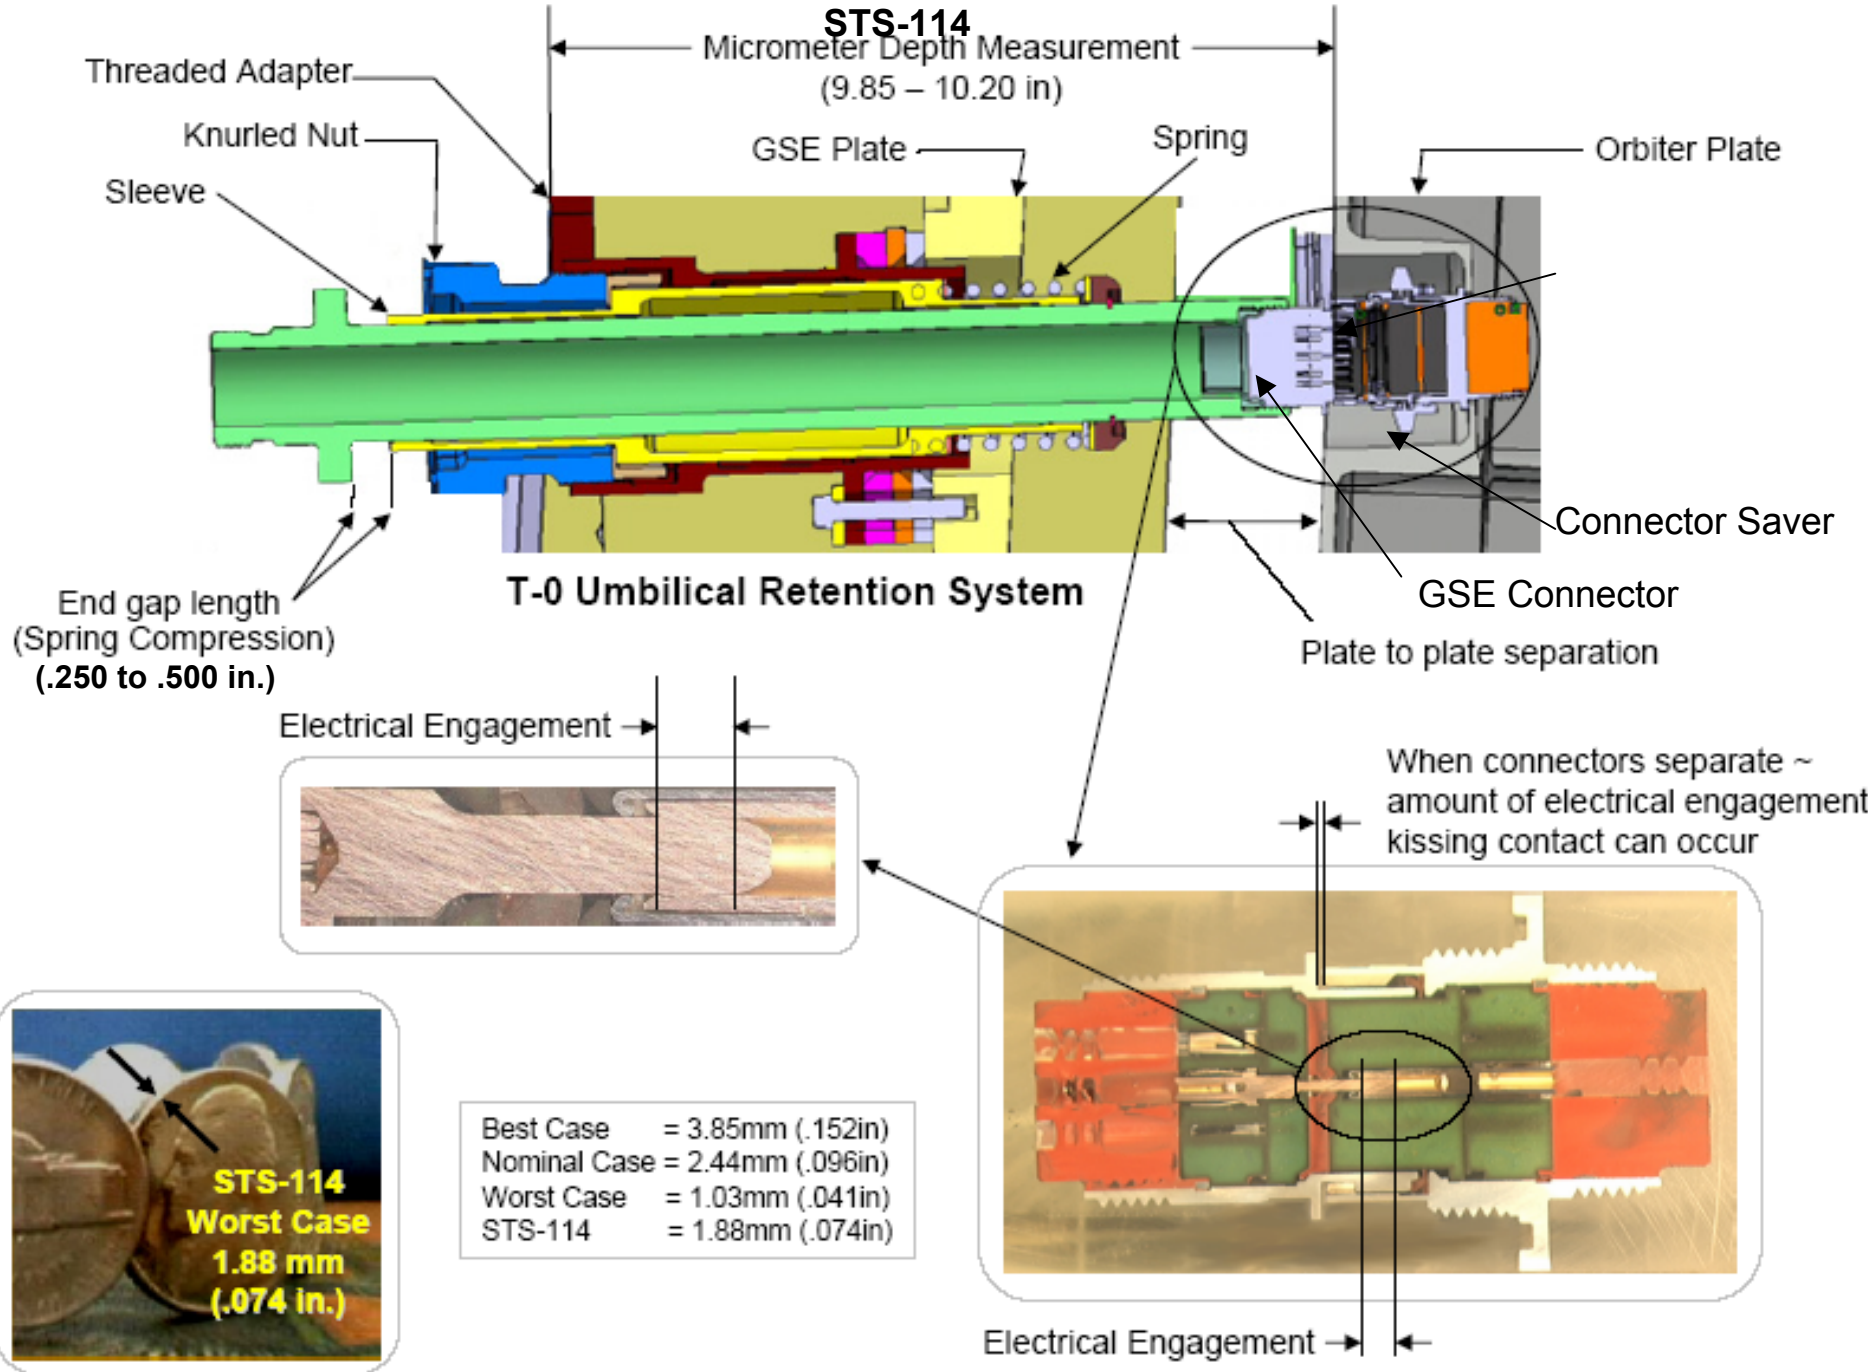
Catastrophic risk from the common cause failure resulting in inadvertent plate / pin / socket separation and loss of electrical continuity to the SRB Hold Down Post Pyrotechnic Initiator Controller Fire 1, Fire 2, and Return paths across the T-O Umbilical due to the dynamic vibro-acoustic environment from SSME startup through T-0.

Independent Assessment Dissenting Opinion on T-O Umbilical Issue

1. Inadequate margin for electrical connector pin / socket engagement. One new STS-114 cable has less than 2 mm engagement. J56, pin J has 1.87 mm (thickness of a nickel) per Shuttle SE&I Office.

3. Inadequate vibration test article, test Y axis only, and no low frequency vibration spectrum below 20 hertz used by STS-112 Standing Accident Investigation Board and SE&I Tiger Team.

4. Inadequate Certification and Qualification of the TSM Electrical System. (Spec requirement-no discontinuity greater than 10 microseconds, only 2 pins / connector monitored, none recorded).

5. Inadequate instrumentation at the T-O interface (electrical continuity or connector movement) during SSME startup through T-0.

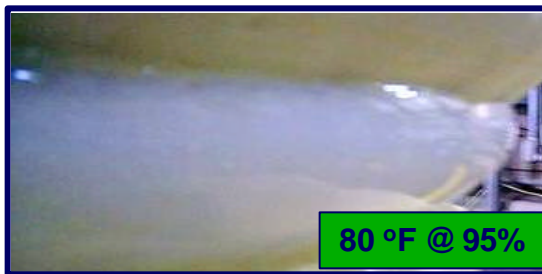
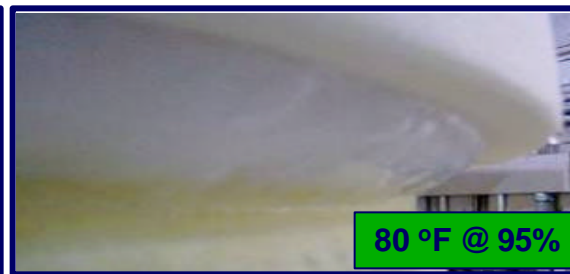
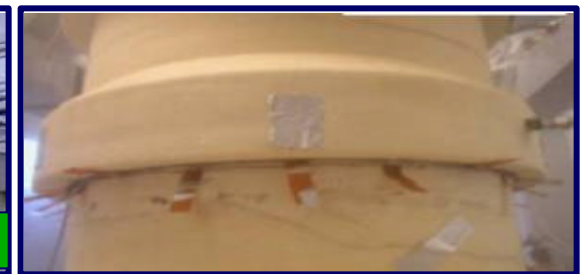
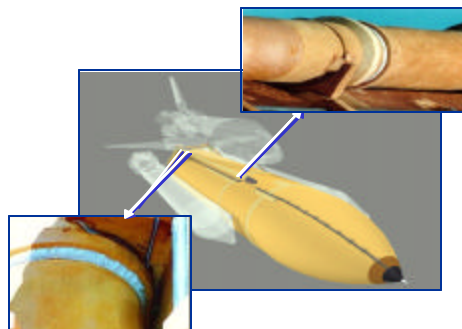
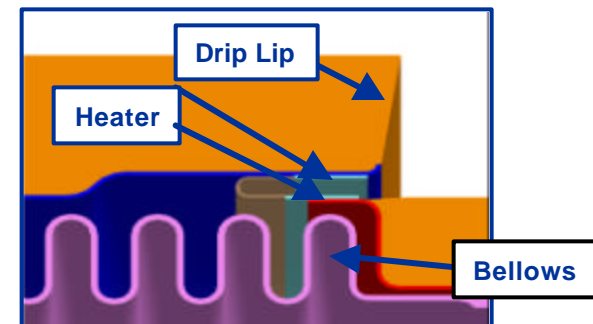
- **ICD updates for ET Bellows heater**

- Added a heater to eliminate ice at the LO2 Feedline bellows cavity
 - Lockheed Martin recommended the elimination of LO2 Feedline bellows ice for RTF
 - Originated by LM Ascent Debris Minimization Independent Review Team (ADMIRT)
 - Accepted by ET RTF project as part of baseline redesign activity
 - Three bellows locations addressed for RTF
 - SSP SE&I/ET Project telecon on 12/02/04 informally directed LMC to pursue heater option for Sta. 1106 (Only) and drip lip only for Sta. 1979 and Sta. 2026

STS-107 Configuration

STS-114 Configuration
